Why I bought our Morris Minor

[Folding head OHC saloon first registered 11th October 1930]

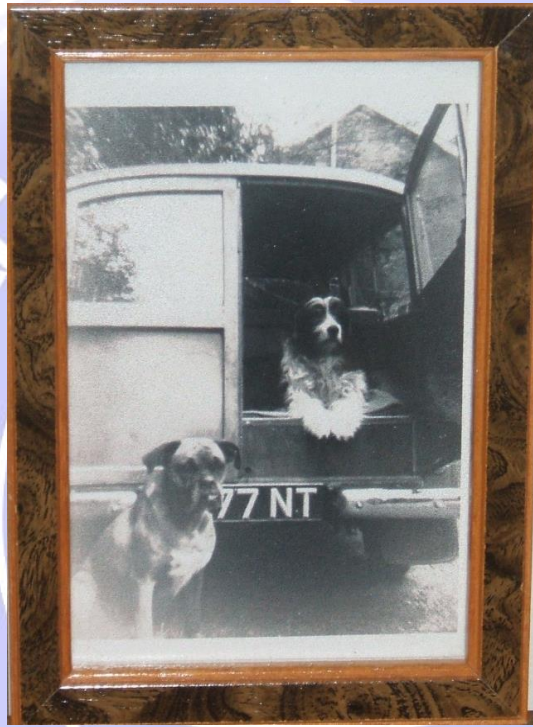
Fig. 1

After full time education I embarked upon a five year engineering apprenticeship. I had no need for a car, travelling to and from work on the local GWR branch line was available and convenient, fortunately, it was the period 'pre-Beeching Axe'. During my apprenticeship I passed my driving test so was able to use the family car on odd occasions to take my girl friend, - now wife – for a ride around the Shropshire countryside. The vehicle in the photograph below was the family car.

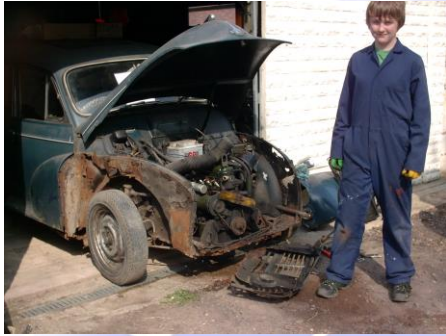
Fig. 2

Fortunately, a member of the group, a professional Morris Minor restoration engineer, thankfully, undertook the bulk of the mechanical work including the replacement of all damaged bodywork once Ben and I had stripped it bare.

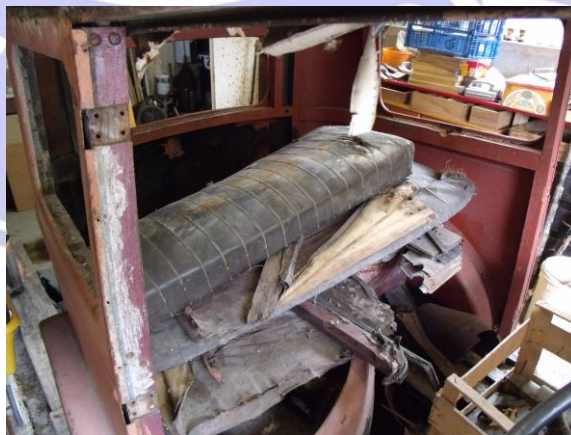
' complete but partially dismantled for restoration. Brass headlights, spare front axle, extra wheels, springs, steering column, tyres and tubes ' – see Fig's 4 & 5 below.

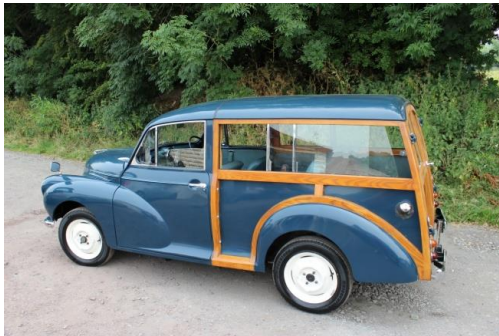
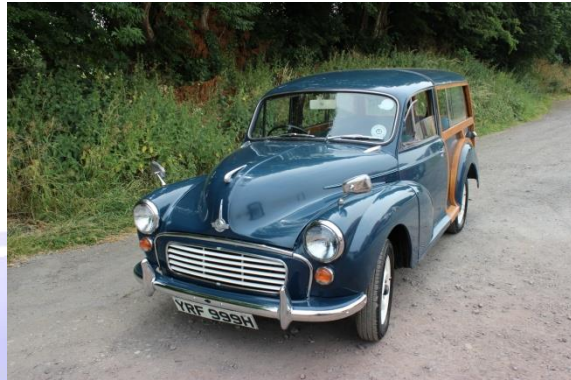
The six year restoration project of the 1969 Traveller was nearing completion. Fig's 6 & 7
The restored Traveller was ready and waiting for Ben to pass his driving test.

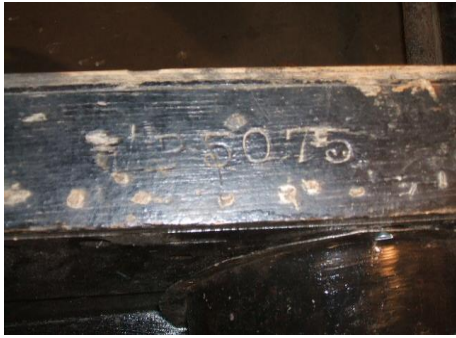
Fig. 8

The photograph, Fig.8 below, shows the October 1930 registered MU 2165 having the MP series body stamp. Fig. 9 shows the three-section metal body shell pressings with depressed lines running down the outside of both rear quarters. The three metal panels seamed at the inside with a cover piece, apparently were only available on the 1929 bodies. The 1930 body has no joins or seams.

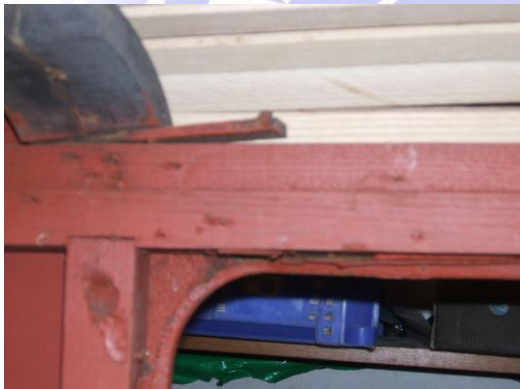
Fig. 10

Fig 10 shows the rearmost roof supports that are packed with wood wedges at the point where it meets the cant rail to fit and support the curve of the metal apron panel.

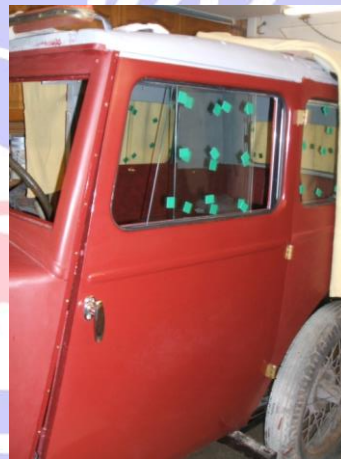
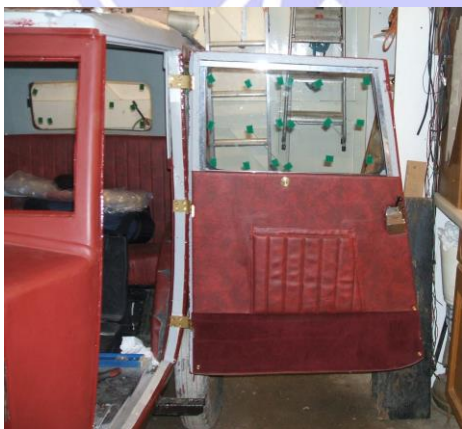
Apparently the early (1929) bodies were fitted with substantial brass hinges, as shown in Fig's 11 & 12. These were plain, with no name stamps, and had a two-into-three leaf arrangement with a substantial peened pin through the centre.
