The early Morris Minor Coachbuilt Saloon bodies

By Mike Houston

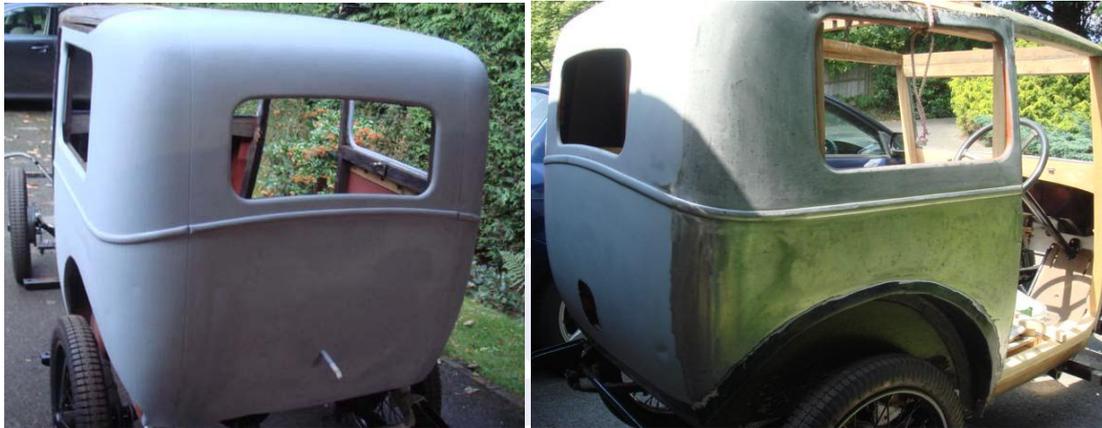
L.H. image shows the two seams resulting from the coming together of the three separate pressed body panels on the 1929 body, while the R.H. image of the late 1930 body shows no such joins or seams.

So a good place to start is with the actual body shell. This largely comprises the rear 'tonneau', the main part of the body taking in the side and rear windows. This seems to always have been manufactured from three pressings. However the first of the 1929 bodies had plain sides and

back, and the decorative aluminium waist moulding was separate, in three pieces, and attached by ten substantial screws either side and eight across the back. A total of 28 screws to be laboriously inserted into the moulding and correctly aligned with pre-drilled holes, the rear ones going right through the main frame under the rear window. The side nuts were separated from the metal shell by thin ply panels. Contrast this fiddly procedure with the later '29 onwards mild steel panels which had the moulding stamped into them at the Pressed Steel factory. These early bodies were the PO series, followed quickly by the MP series, of which more later.

Thus the panels themselves differ from early to late. Furthermore the three panels were welded differently. The early ones were seamed to the inside which were turned and welded, and a cover moulding piece welded, maybe in one operation, over the top. Thus the cover piece is visible inside the body. The seam is visible from the outside as a depressed line running down both rear quarters. On the later body there is no evidence of the panels being welded either internally or externally. The joining line only becomes visible when considerable force is exerted across the join, when the line of the join becomes clearly visible. Which begs the question, how were these later panels joined? Most likely appears to be the use of the Flash Welding technique. The panel edges would have been brought together very accurately in a jig, and a high current 'flushed' across them, thus fusing them. These production techniques are worth further research.

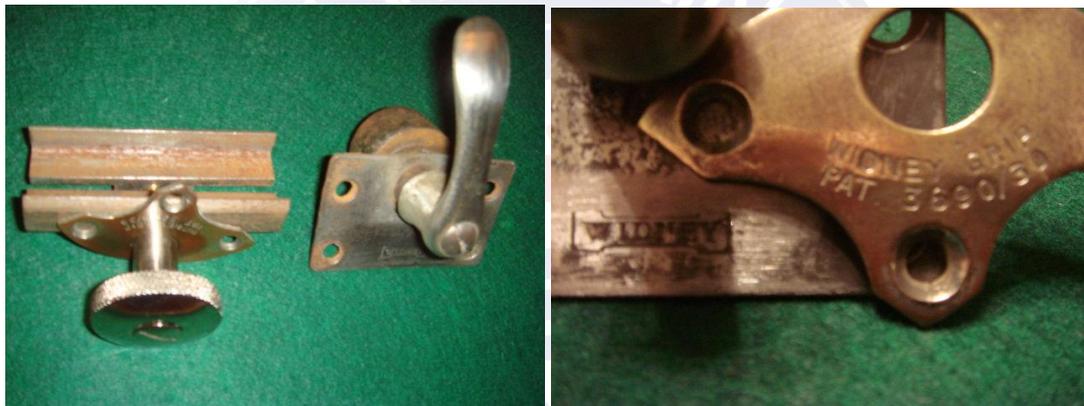
The Widney Eccentric Cam from the 1929 body while the Widney Clamp was used for the 1931 season cars.

Mention was made above of the side elbow rails. These altered between the '29 and '30 bodies, although I don't know exactly when, as did the below window rail in the door frame. This was to accommodate the changes in the window clamps to secure the sliding windows. The earlier car uses a 'Widney' eccentric cam with nickel plated operating lever to raise the window channel upwards at the centre point, thus jamming the glass panes in place. This required an almost full circle cut out of the aforementioned rail to accommodate it. The following year came the 'Widney clamp', patented in 1930. As its name implies this featured two metal, (I've seen both brass and ferrous ones), clamps sitting on contra threads which are drawn to each other by rotating a round knob (chromed brass?), thus clamping the glass through the runners from the sides. Again I would think cheaper to produce. The earlier lever type was fitted with rectangular escutcheon, or cover, plates. The round variety had a triangular type of plate. Both were produced in brass, and some were chrome plated.

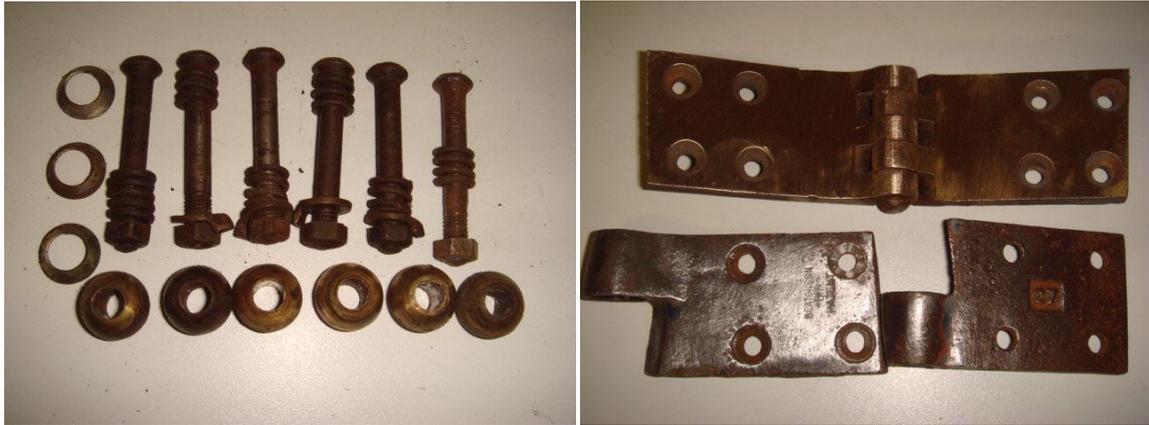
The R.H. image clearly shows the differing types of door hinge used – the early body was fitted with the substantial plain hinges (top) while the 1930 body was fitted with the numbered 'Beatson' type. The L.H. image shows the pins and fitments for use with 'Beatson' hinges.

Another body fitment to change was the hinges. The earlier bodies sported three substantial brass hinges on either side, plain with no name. These had a two into three leaf arrangement with a substantial peened pin through the centre. Thus there was no method of adjustment for fit meaning that the initial fit had to be spot on. The indications are that these hinges only went on the very earliest bodies. The later hinges are cast by 'Beatonson'. They are of similar construction to the old railway carriage hinges, the lower supporting part on the body, and the upper part on the door. The upper sits on a brass ball cupped between both parts, connected by a pin with a keyway in the bottom. A spring is placed in the bottom part of the hinge, then a securing tab washer fitted into the keyway, then the lower nut secured by folding over the tab. Rounded washers can then be used to fit under or over the brass balls for adjustment. These hinges are each individually numbered, presumably to assist in the ordering and fitting process. The nearside numbers are: - top 25 – middle 27 – bottom 29. The offside numbers are: - top 32 – middle 34 – bottom 36. Aesthetically the brass hinges have, I think, the better appearance looking less bulky. There may have been supply issues, or it might have been thought that with the heavy saloon doors the brass might have worn quickly? Again cost, and continuity of supply, may have played a part.
